History

Tips & Tricks

Smart building system UWP 3.0

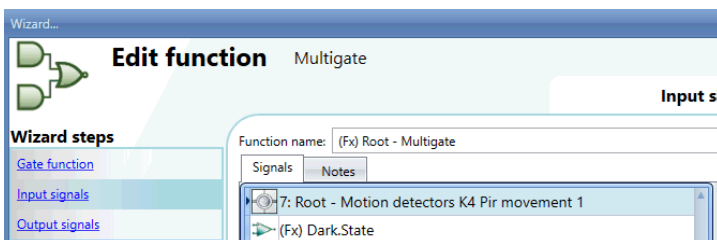
The automation of the light function puts together lux meter, PIR and energy save timer. When the lux value is below the threshold and the PIR detects movement, the light goes on. At this point the lux value goes above the threshold and the energy save timer is not reloaded anymore, therefore the light goes off even if there is presence in the room.

Create an external analogue comparator that is used to define the “dark” condition. Use the comparator function as input of a multigate “AND” function combined with the *movement signal* of the PIR sensor.

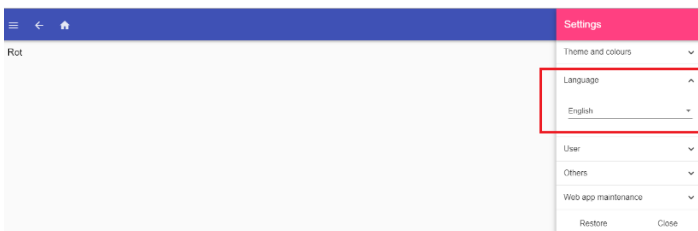
In the web app *Reports* window, you have created a template for a report in October 2018 but when you save and create the report, November 2018 data logs are shown.

You may face this issue if you run a Web browser with Norwegian or Chinese language.

The problem is due to the wrong default language that is automatically set by the Web App.

To fix this issue, navigate the web App settings, select the English language, then select again the correct language and save to apply the settings.

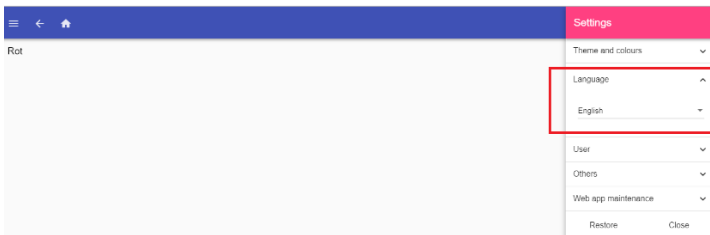
When you try to edit a calendar activity from the Web App, you get an error and the login page is shown.

You may face this issue if you run a Web browser with Norwegian or Chinese language.

The problem is due to the wrong default language that is automatically set by the Web App.

To fix this issue, navigate the web App settings, select the English language, then select again the correct language and save to apply the settings.

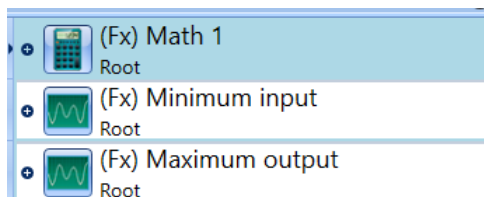
In the Database window, the additional function status of a function is not available and it is not possible to log them into the Database of the system.

- a. Add to the project one Analog Output function for each additional status not available in the Database.

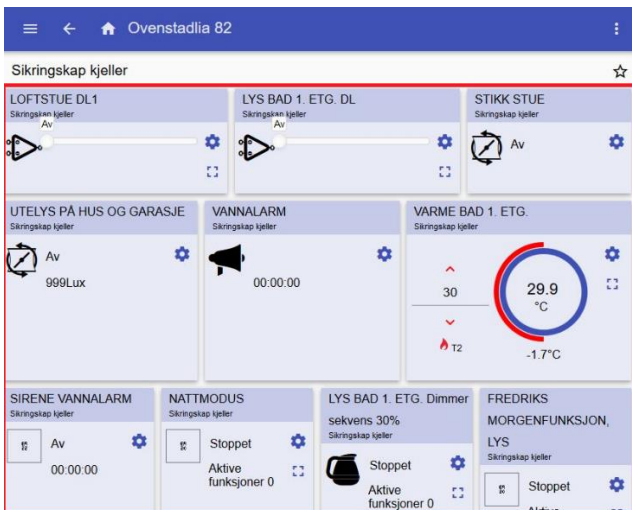
After a firmware upgrade of the system the icons in the web App are not correct (the icons are messed up or missing).

The error is due to the cache of the web browser, the issue will be resolved cleaning the cache and logging-in again in the web App.

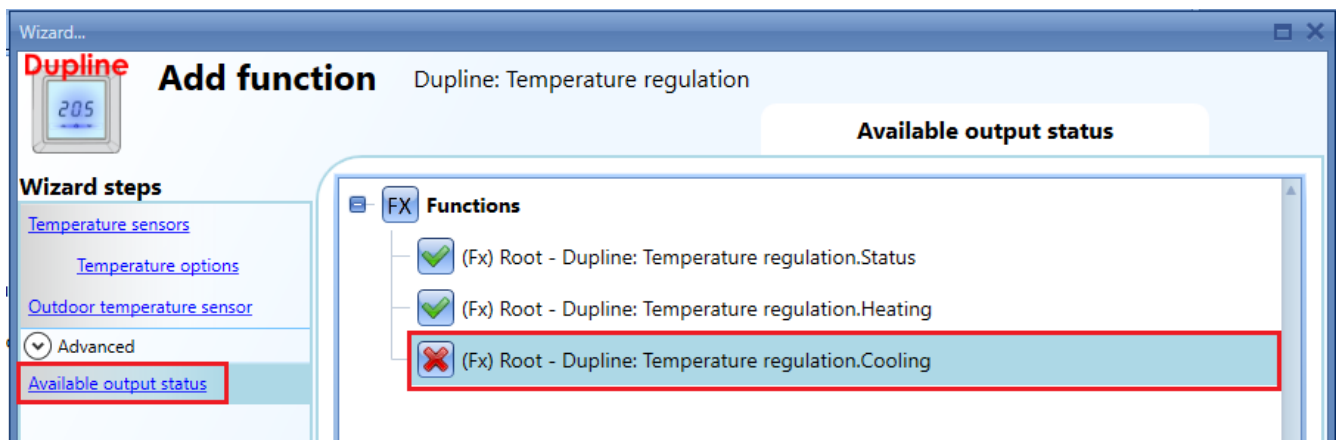
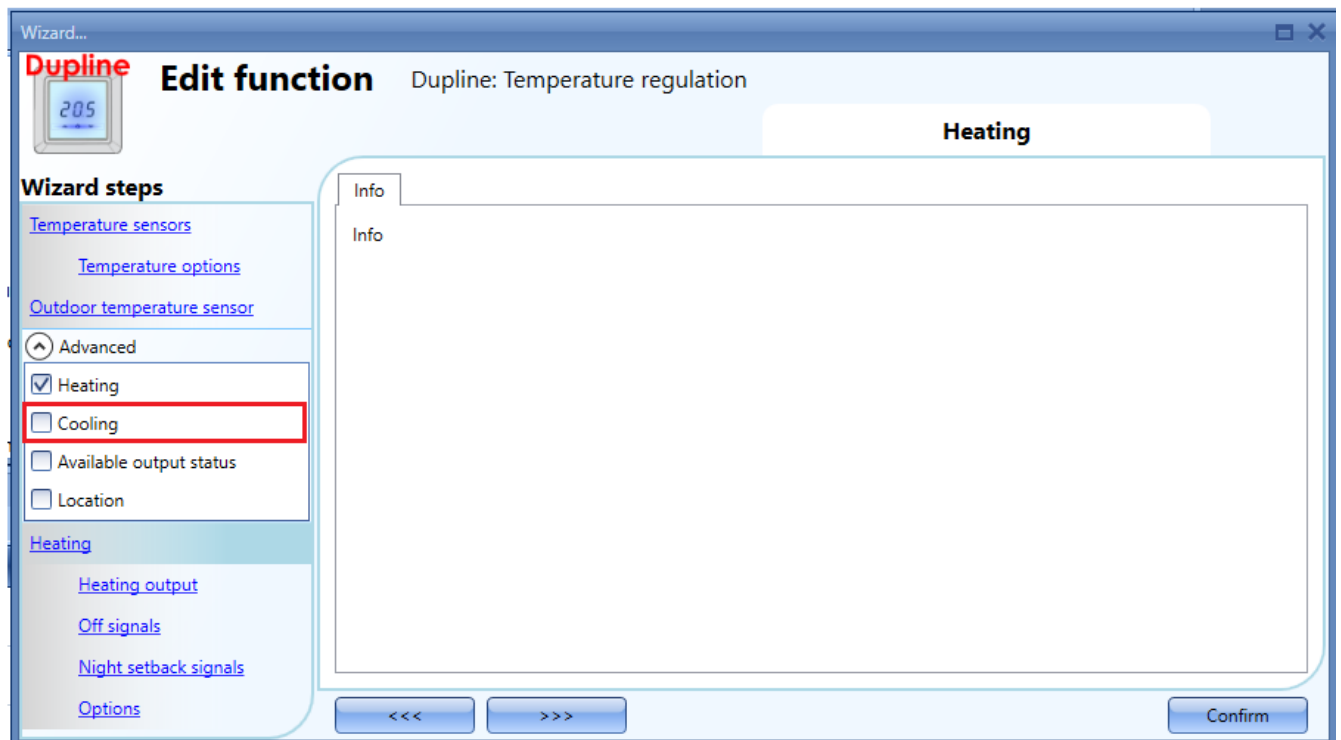
When the advanced field Cooling is selected in the Dupline temperature regulation and there is no output signal used, the temperature function activates the cooling set point every time the configuration file is sent to the controller, consequently the heating function goes from heating T1 to TOFF and stops heating. This problem happens also when the controller restarts because the system loads the configuration at start-up and the cooling setpoint is activated.

In the advanced menu “available output status” the signal *temperature regulation.Cooling* should be deactivated.

The advanced menu “Cooling” should be unselected.

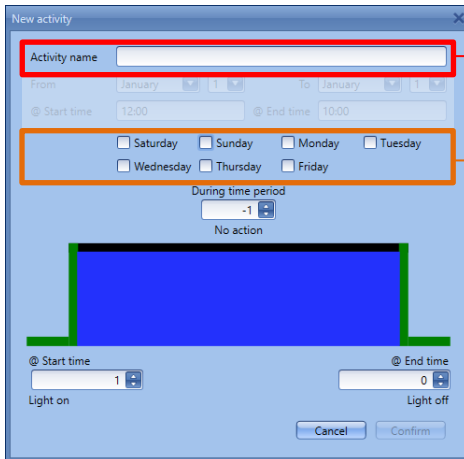
When a calendar activity is going to be added either in the *Local calendar* of the functions where it is available in the *Advanced* options, or in the *Global calendar* function, after filling the required fields the *Confirm* button cannot be pressed (this is shown in grey colour).

This happens if at least one of the following conditions is verified:

The *Activity name* field has to be entered

At least one week day has to be selected
